BCT Meeting Agenda April 25, 2006 Tetra Tech EMI– San Francisco Office 135 Main Street, Suite 1800 10:00 –14:45

Hunters Point Shipyard Meeting Attendance Sheet

Time Critical Removal Action Update Hunters Point Shipyard

Base Closure Team Meeting April 25, 2006

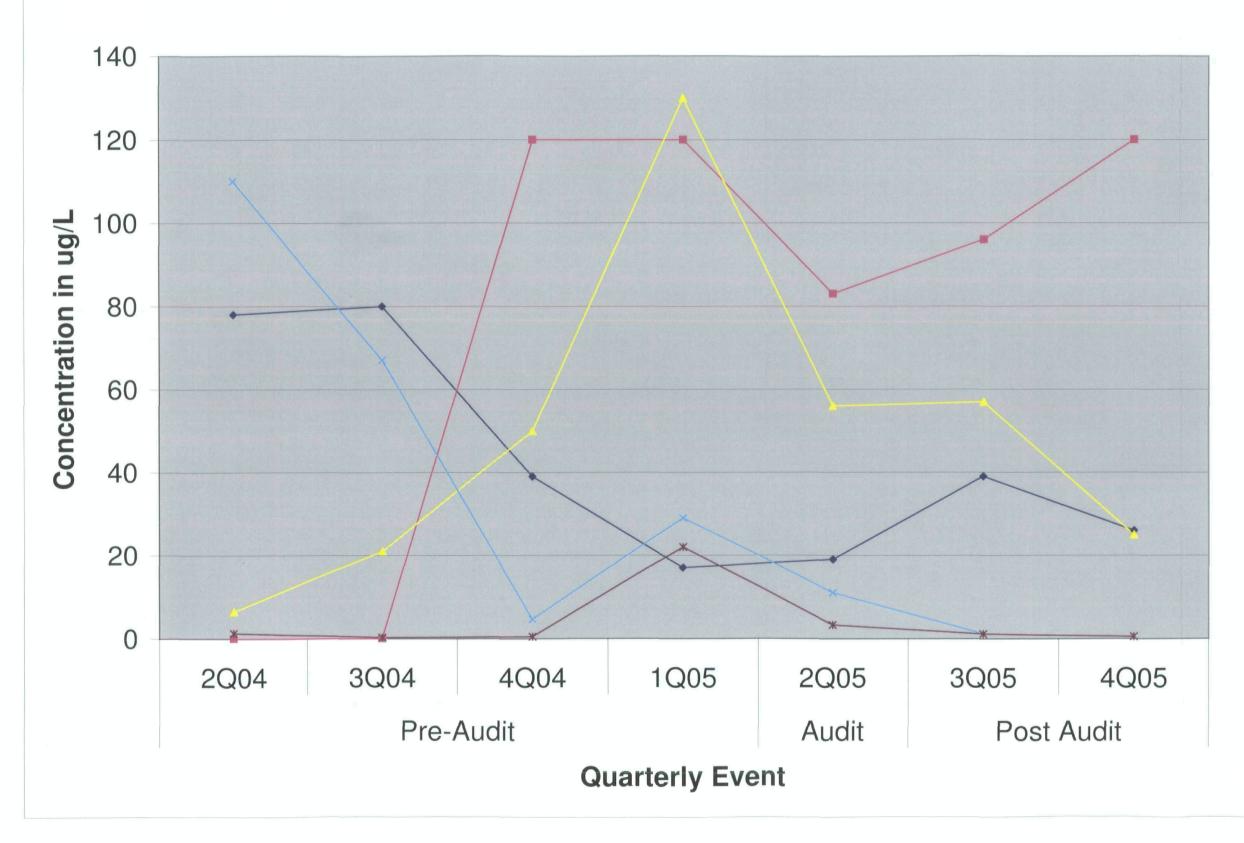
Vinyl Chloride Maximum Concentration 130 ug/L

- → IR06MW59A1
- IR28MW136A
- → IR28MW211F
- → IR58MW33B
- → IR58MW32B

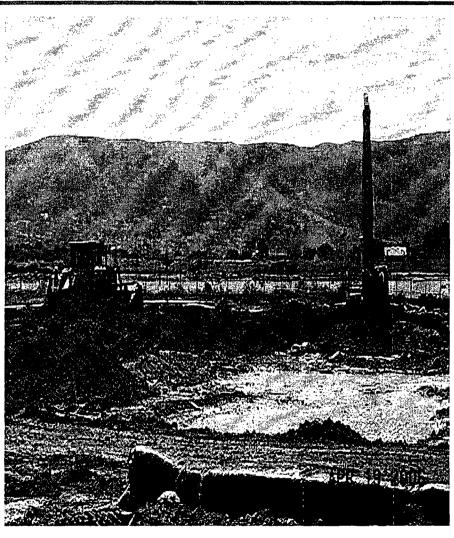
PCB Area April 2006

- •25,250 cubic yards removed (total estimate is 31,000 cy)
- 26,600 cubic yards rad-screened to date
- Initiated "potholing" southwest of excavation area
- Oily soil and groundwater present at 10 feet bgs

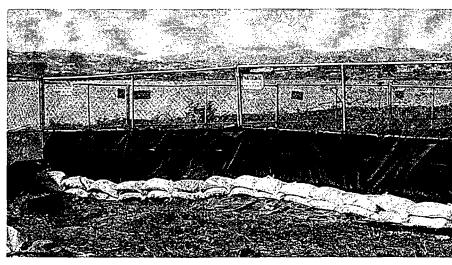
Storm Water Control
Measures Along Northwest
Fenceline

- 1,813 cubic yards of general debris including large rocks, asbestos-containing materials, concrete, crushed drums, scrap metal, and spent shell casings
- Stormwater pollution control measures are inspected and upgraded or repaired as needed.
- 203 bins rad-contaminated soil transported off site
